## IVECONNECT UPDATE PROCEDURE

### Iveconnect System Update

### **Iveconnect Applications Update**

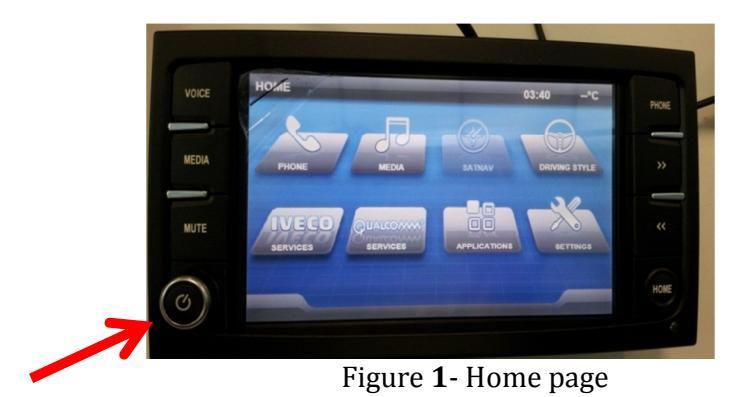
A. Switch ON the Iveconnect system by pushing the power-on button *one page appears (see Figure 1 - Home Page below)*, confirm the Disclaimer

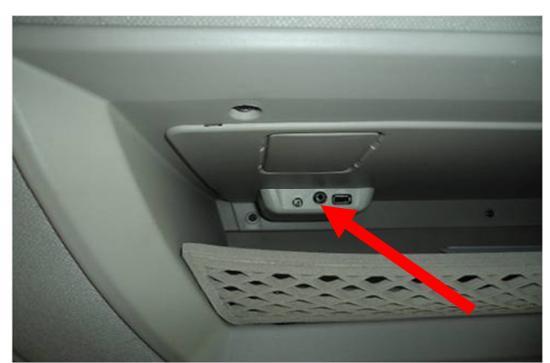
Figure 2 - Location of the USB connector on the upper shell

B. Plug the USB PenDrive containing the 3 files listed above into the Iveconnect USB connector located on the upper shell of the vehicle (see Figure 2).

- A. With the Home screen displayed, insert the USB pen-drive on the USB connector on the upper shell (see Figure 2).
- B. Wait until the reboot notification windows is displayed and answer yes to the request to restart the lveconnect system. As soon as the system is restarted, the applications installation procedure will start and a screen similar to the one reported below will appear.

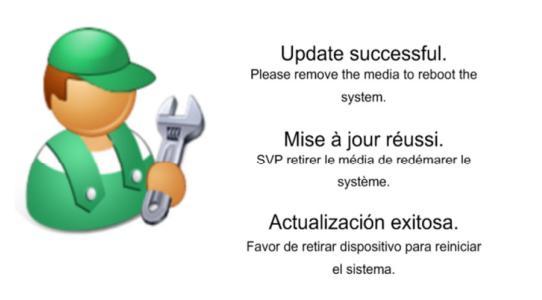
Figure 4 – Update Completed

E. In case the update is completed successfully, the following image will appear.

F. Now the update is almost complete, unplug the USB Pen Drive, press the button is to switch off

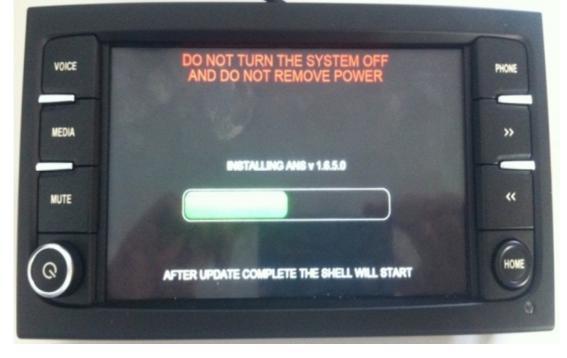
Figure 7 – Application Installation Progress bar

C. During the progress of the Application update procedure various screens reporting a green progress bar will be displayed (see figure 7).

In case the progress bar gets red instead of green, this means the application update procedure has failed. In this case, PLEASE REMOVE USB PENDRIVE, wait for the system reboot and re-start the <u>Application Update</u> procedure from point A above (in case the home page does not appear switch-off the system by pressing the button  $\bigcirc$ , wait few seconds and press it again  $\bigcirc$  to switch-on the system).
